Lenzie Moss Local Nature Reserve

Streetscene Technical Support Update from J.Gillespie, Streetscene Project Officer

June 2023

Lenzie Moss Path and Boardwalk Upgrade Works

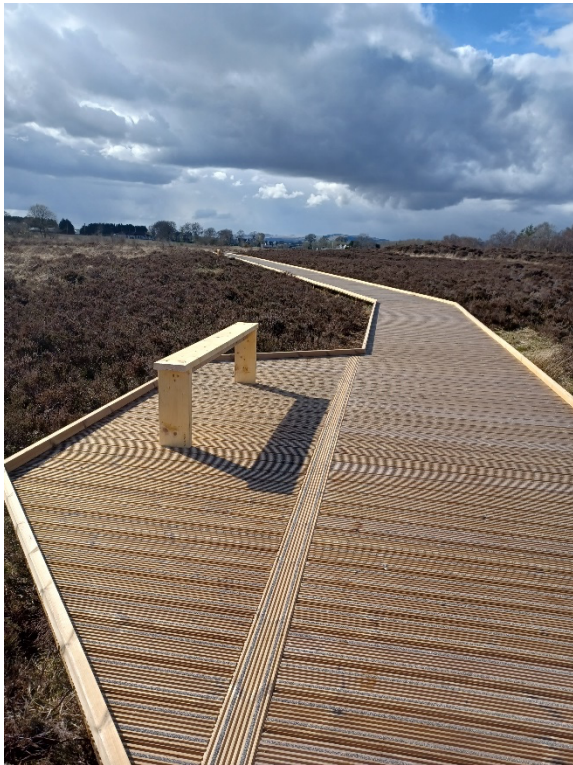
The decking boards for the boardwalk are made from heat treated Thermopine timber.

Thermopine is a product with enhanced stability and durability, produced by modifying European-grown Scots Pine, using only heat, steam and pressure. This results in reducing the wood's tendency to shrink and swell and also reduces its vulnerability to wood destroying organisms. This means that no chemicals have been used in its production thus reducing the chemical impact upon Lenzie Moss and the overall sustainability of the product.

Thermal treatment results in substantially reduced swelling and shrinking of the timber, reducing dimensional movement by up to 50% making Thermopine a very stable timber. The heat treatment also reduces the vulnerability to wood decomposing organisms.

The boardwalk width was extended to a working width of 2 linear meters. This was to allow ease of movement by all users including walkers, cyclists etc. Extended areas with seating were included to afford views of Lenzie Moss and to allow visitors the opportunity to take time to enjoy the locale.

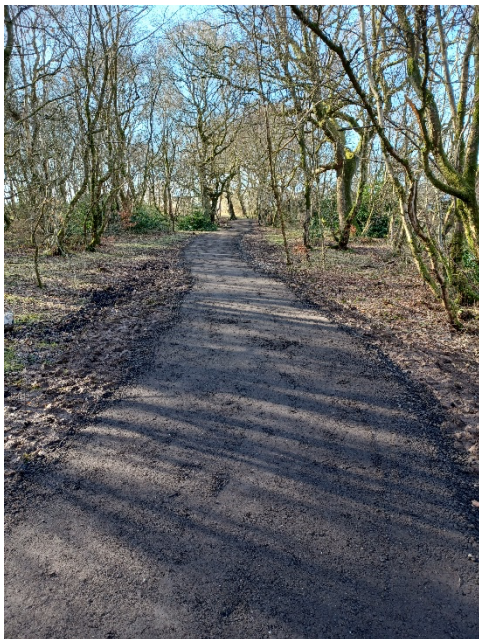
The path upgrade was in the main a top dress of Pavetrec. This product consists of milled road planings and is the original material used on the Lenzie Moss paths. Sixty linear meters of path were upgraded into a raised path causeway due to that section of path flooding on a regular basis. Associated ditching was carried out to move water away from that section of pathway.

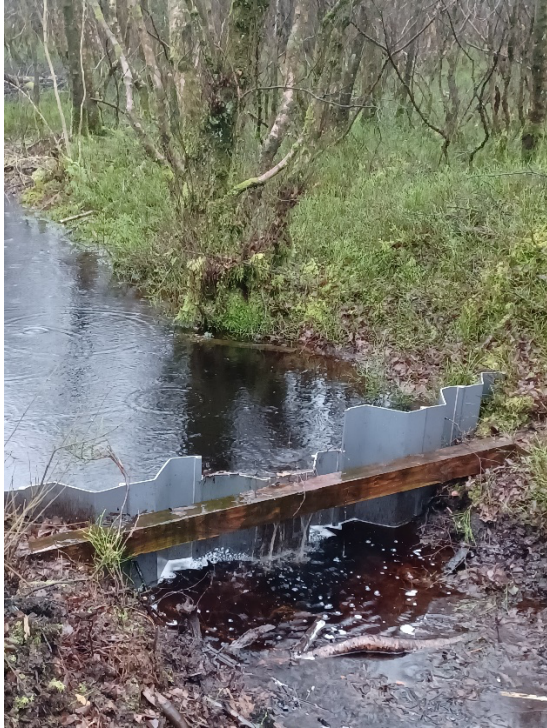
Drainage ditches were cleaned in the North Woods to assist with water flow away from certain areas of housing. In addition, and to assist in slowing down water flow a number of drainage ditch dams were installed.

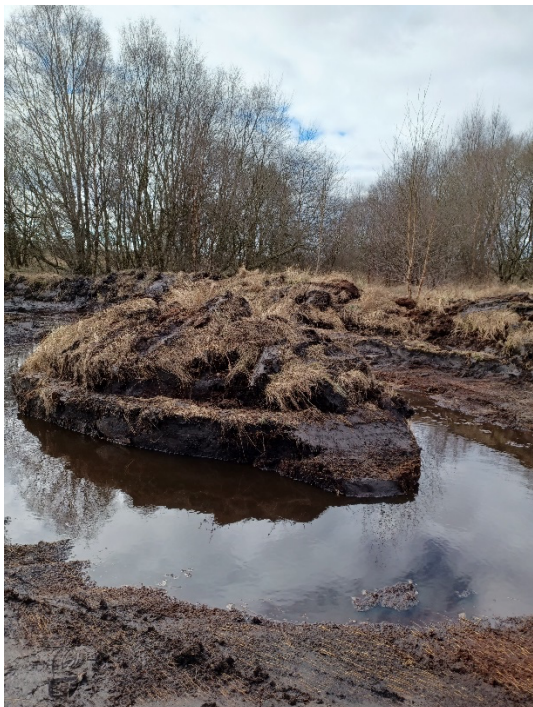
Pond immediately after construction March 2023

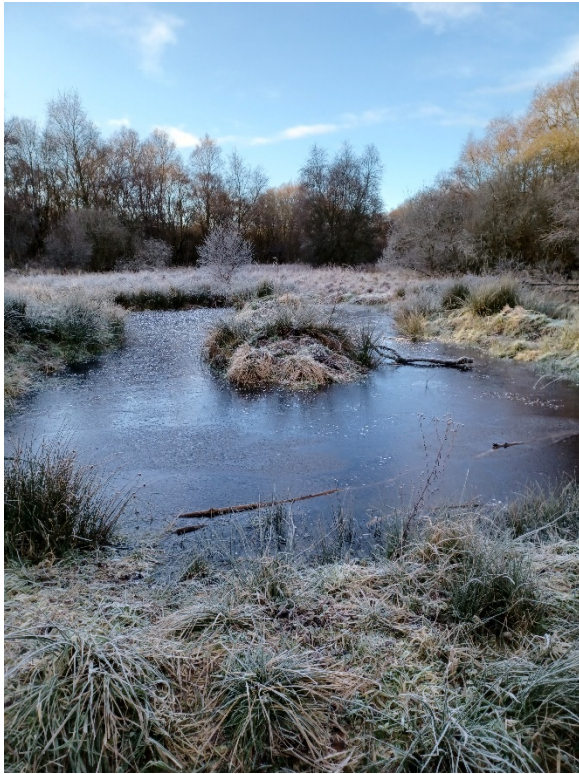
Pond constructed in Spring 2022

At Lenzie Moss, Water Voles have recently been discovered living as what is termed Fossorial Water Voles. They have developed the behaviour to live underground in grasslands in a mole like way. 2022 saw bunds being created in the Heather Drive area. These bunds have proved to be extremely successful with many Water Vole tunnels being observed in them. The bunds help protect the Water Voles from predation and provide for them a drier winter habitat. In addition, ponds were created in 2022 and 2023 to provide additional Water Vole habitat and for other wildlife such as Amphibians and Dragonflies. The bunds are wider at the sides of the newest ponds to provide enhanced protection from predators.
